# Fire Engineering®

## **Construction Concerns: Delaminated Plywood** **Article and photos by Gregory Havel**

*November 3, 2011*

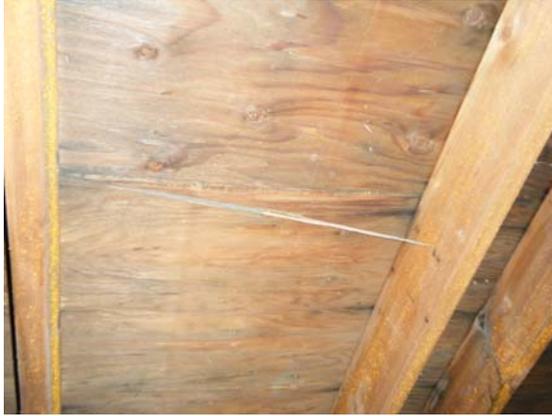
An example is a wood-frame, single-family residence built in Wisconsin in 1964. Forty-five years after construction, the roof began to feel spongy underfoot in places and to sag between its rafters. Photo 1 (*top left*) shows the exposed underside of the plywood in the attic; the plywood is delaminated and beginning to fall apart. This plywood is ordinary CDX and had not been treated with a fire retardant. The underside of the roof did not show evidence of leaks.

Today's building codes recognize that ventilation of attics and cocklofts is necessary to prevent the deterioration of both sawn lumber and man-made wood products and to prevent the saturation of insulation by condensation. Codes today require larger areas of inlet and outlet ventilation than in the past. Section R806.2 of the *International Residential Code (IRC)*, 2009 edition, requires that the "total net free ventilating area" shall be not less than 1/150 of the area of the space ventilated. A reduction in the amount of ventilation needed is allowed if certain conditions are met. State, local, and other codes have requirements similar to those in the IRC, although the amount of ventilation required can vary among jurisdictions.

If a roof feels spongy, question its structural integrity, and do not walk on it. If a roof shows sags between its rafters or trusses, do not go on it for vertical ventilation. Although a spongy or a sagging roof may be structurally sound under ordinary conditions, it may not be strong enough to support a team of firefighters and may collapse even if there is no fire below.

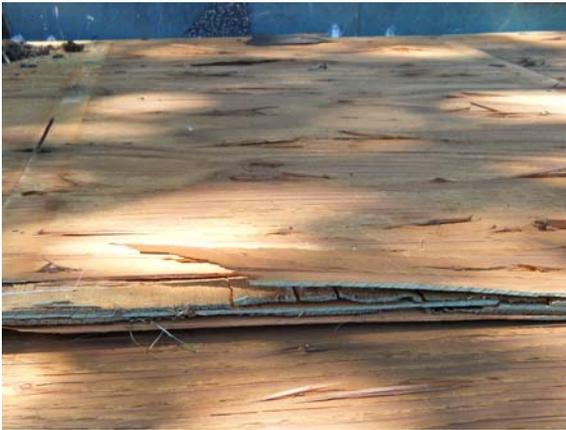
Photo 2 (*middle left*) shows a sheet of the delaminated plywood after it was removed and replaced last summer. Note that all five layers are separated and the middle layers are curling and cracking from repeated heating and cooling. Some of these plywood sheets were so weakened that the contractor was able to remove them by hand, using tools only to pull the remaining nails from the rafters.

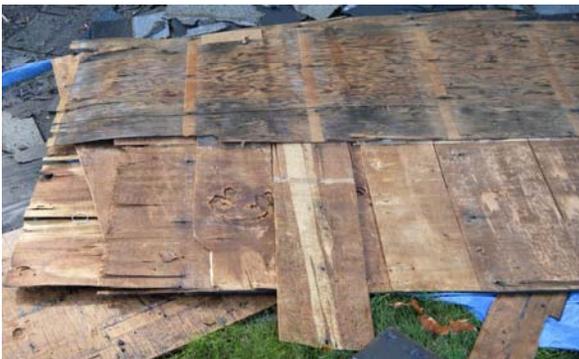
Photo 3 (*bottom left*) shows part of another sheet of plywood that was removed by hand and which has no strength left and no adhesion between the layers within the plywood.
