Construction Concerns: Structural Collapse **Article by Gregory Havel**

June 24, 2013

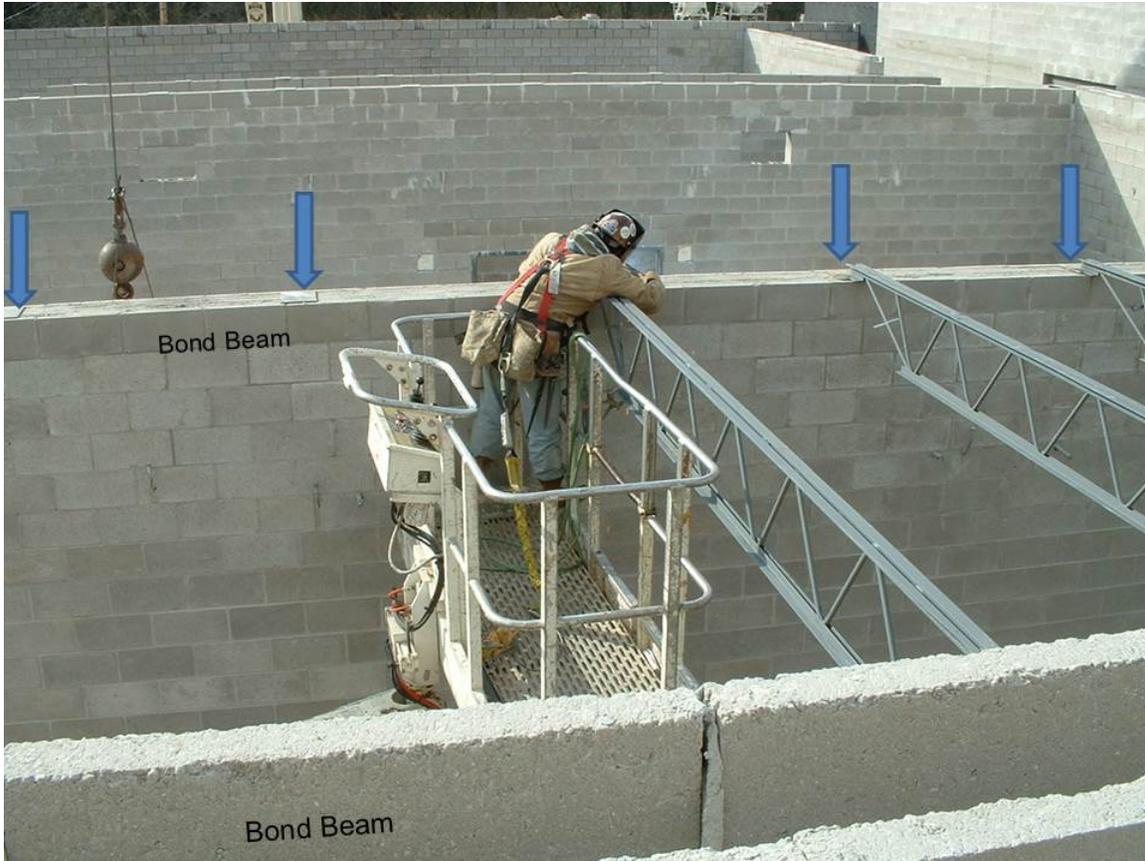
Photo 1 shows a non-combustible (Type II) building under construction. The steel bar joists are being set between the load-bearing masonry walls in the foreground and in the middle. The top course of concrete masonry units on the middle wall is a “bond beam”-- blocks with a U-shaped cross section. This U-shaped cavity forms a continuous channel in the top of the wall which is filled with reinforcing steel and concrete grout to stiffen the top of the wall and provide for the installation of “setting plates” (at the arrows). These in turn are embedded in the concrete grout and the bar joists are welded to them. The top course on the wall in the foreground will also be a bond beam, after the installation of the reinforcing steel and concrete grout. The bar joists will connect and stabilize the walls; and the steel roof deck that will be welded to the bar joists will provide resistance to lateral and other forces that may be applied to the completed building.

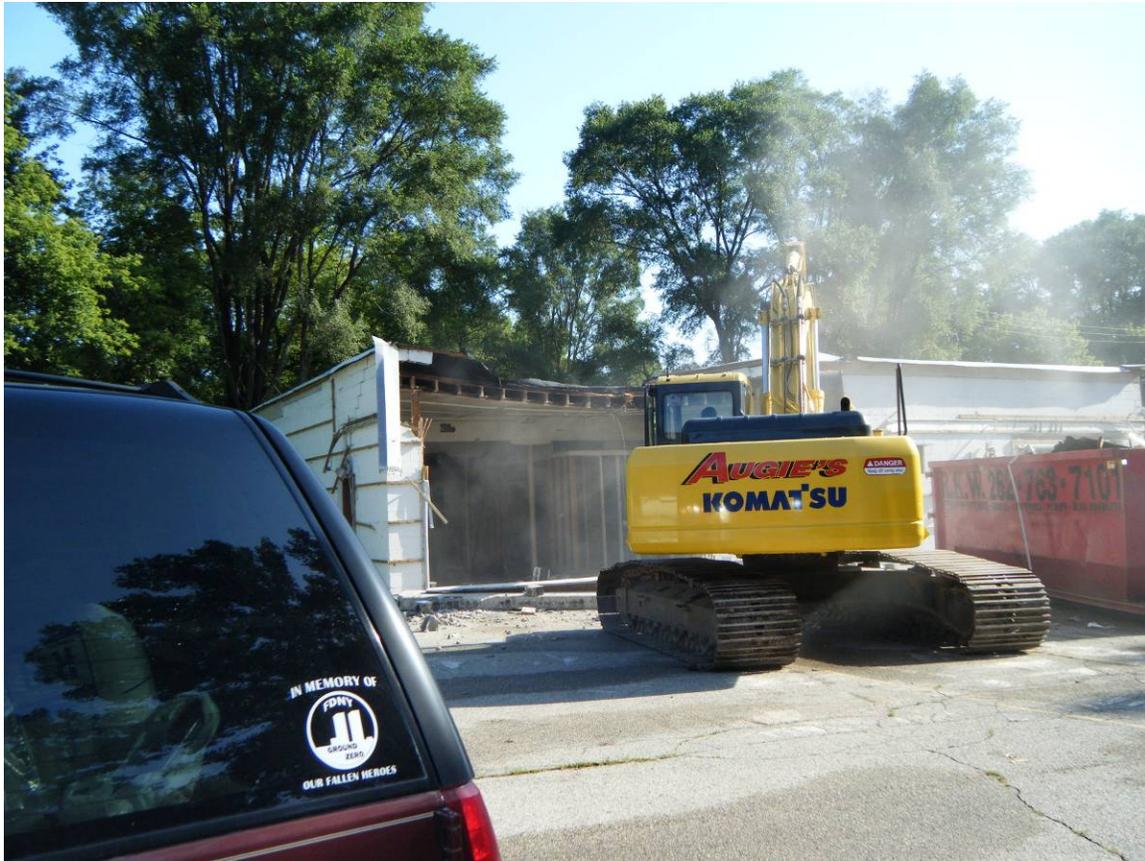
Photo 2 shows a single-story building under demolition. The lintel over the garage door has been removed, also removing the beam that supported the ends of the roof joists. These roof joists are sagging, exerting an inward force on the walls, attempting to pull them in. This is similar to what happened in Philadelphia, except that in Philadelphia, the beam that was removed destabilized a four-story wall that swayed and collapsed outward. In Photo 2, the collapse zone was marked, cleared of all by-standers, and spotters were assigned to keep spectators away.
